vLA1

Sinclair Interface 1 ULA replacement Installation Guide

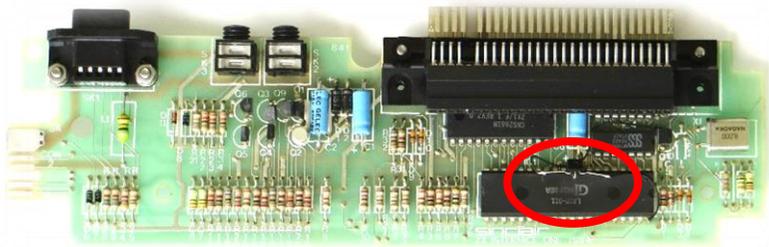
You will notice that there is a transistor modification (Q11 on the service manual schematic) attached to the existing ULA. This can usually be removed as it is not needed by the vLA1. If you do intend to install an original ULA in the future then best to keep the modification in place.

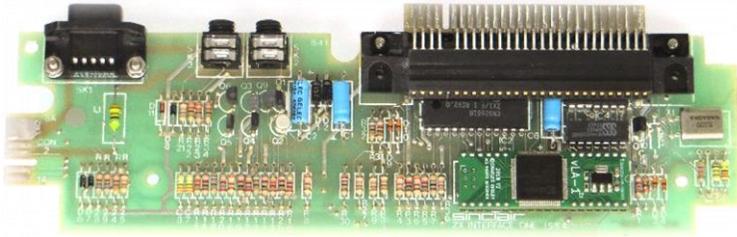
Once the existing ULA has been removed then simply drop the vLA1 in place. The orientation is as shown below (soldering it in the wrong way will mean yet another difficult desoldering job!).
